The Moors at Arne Coastal Management Project Groundwater Survey

September 2018

Ridge Surface Water

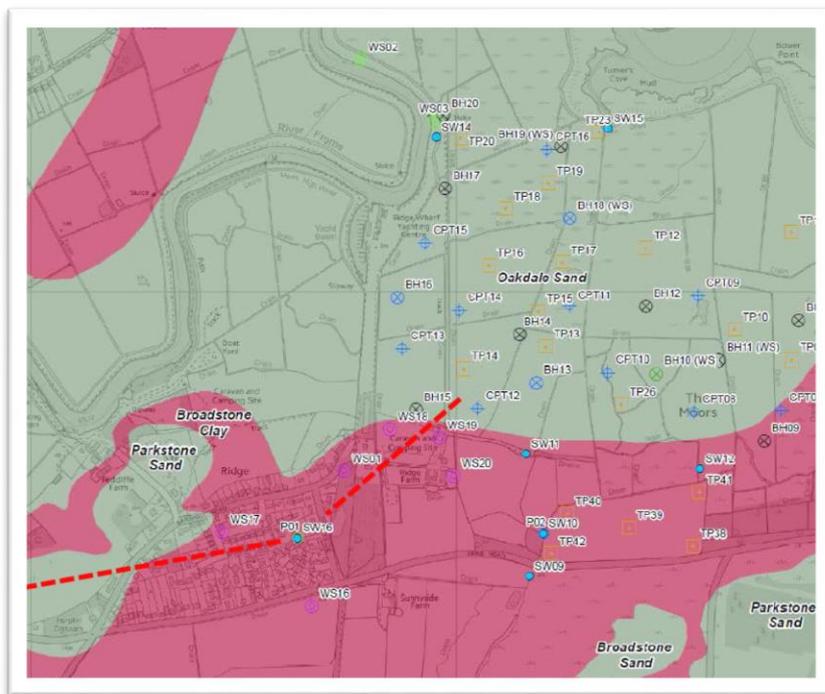
Mapping produced by the British Geological Survey (Extract below) shows that in Ridge there are combinations of sandstone and clay layers forming the solid geology.

Solid Geology	
●	Borehole location
	Clay
	Sandstone
- - -	Schematic section

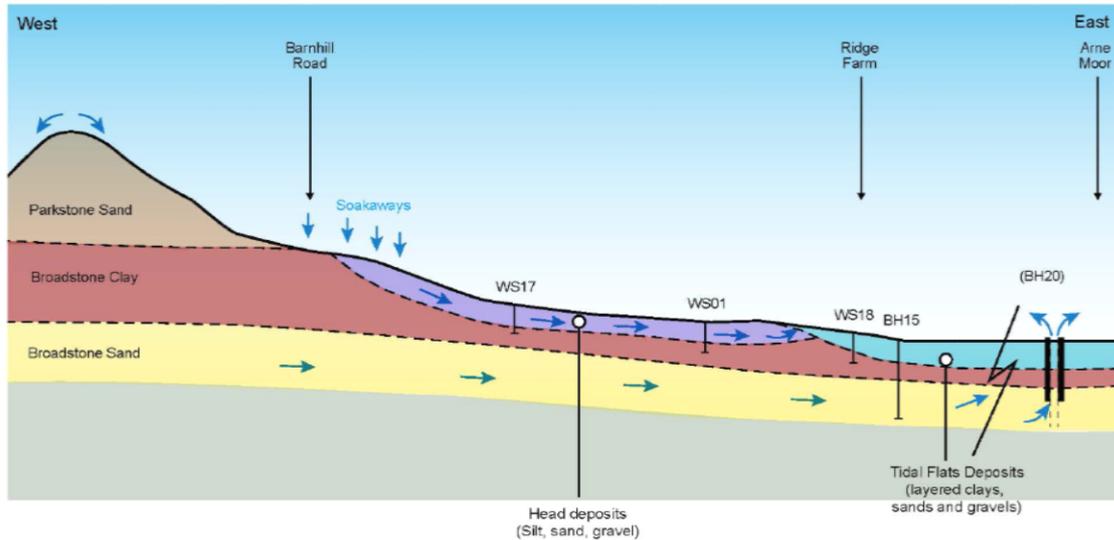
Initial conceptual understanding (schematic section)

Our investigations have located layers under Ridge which are capable of transmitting groundwater. These are typically granular “soils” (such as sands and gravels). Where clays occur above or beneath these granular layers they prevent water “soaking in” or downward into underlying layers. Clays may interrupt both vertical and lateral flow of groundwater.

Our boreholes have shown that there is a second deeper groundwater aquifer which flows under Ridge towards the River Frome which is isolated from properties in Ridge by an intervening layer of clay.

The groundwater level monitors indicate that there is no correlation between water levels recorded in Ridge and the height of the tides. We conclude from this that there is no physical connection.

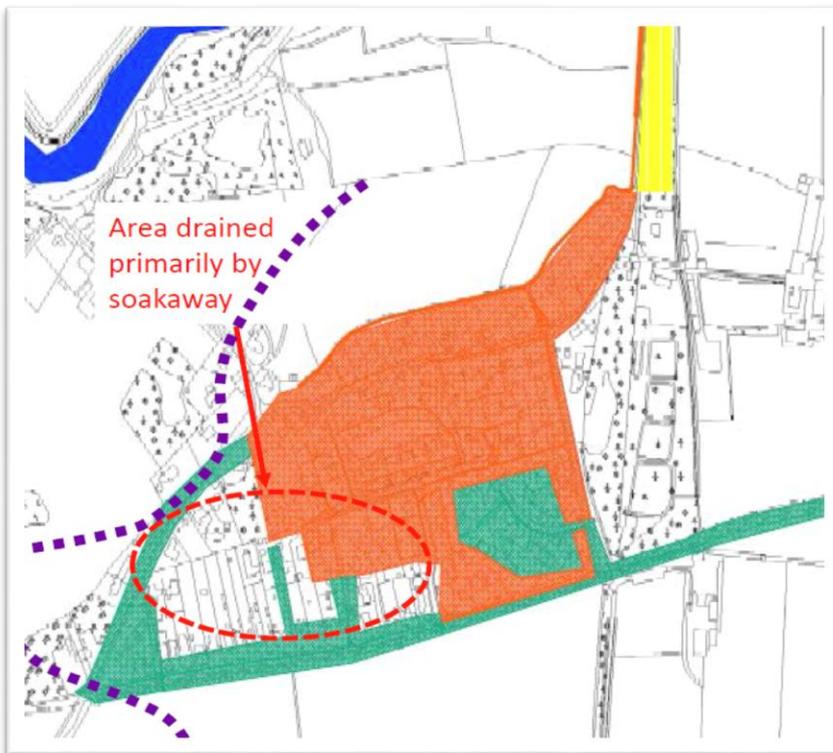
Boundaries of rainfall runoff catchments, indicating break of slope

Area of made ground acting as a barrier

Area connected to systems which drain to the North

Area connected to systems which drain to the East

Soakaways capture surface runoff from roofs and paved areas feeding water into the ground

In the map above of Ridge, the green area drains out eastwards towards the Furze Brook via the ditch alongside the Arne Road. The orange area drains northwards to the river meadow via the bottom of Barnhill Road. This area has no drainage connection with the project area of the Moors at Arne. There is a zone where property surface drainage goes to soakaways shown within the red dotted area.

This Ridge surface water drainage catchment map is based on detailed survey and technical assessment, if you have any requirement for clarification or details from the CCTV record please let us know.

The surface water drains from Ridge will be unaffected by any proposed changes by the Moors project because the lowest point of discharge from pipe to open ditch is at least 0.5 metres higher than the most extreme tidal storm level predicted.
