## East Beach briefing note

### Current beach conditions

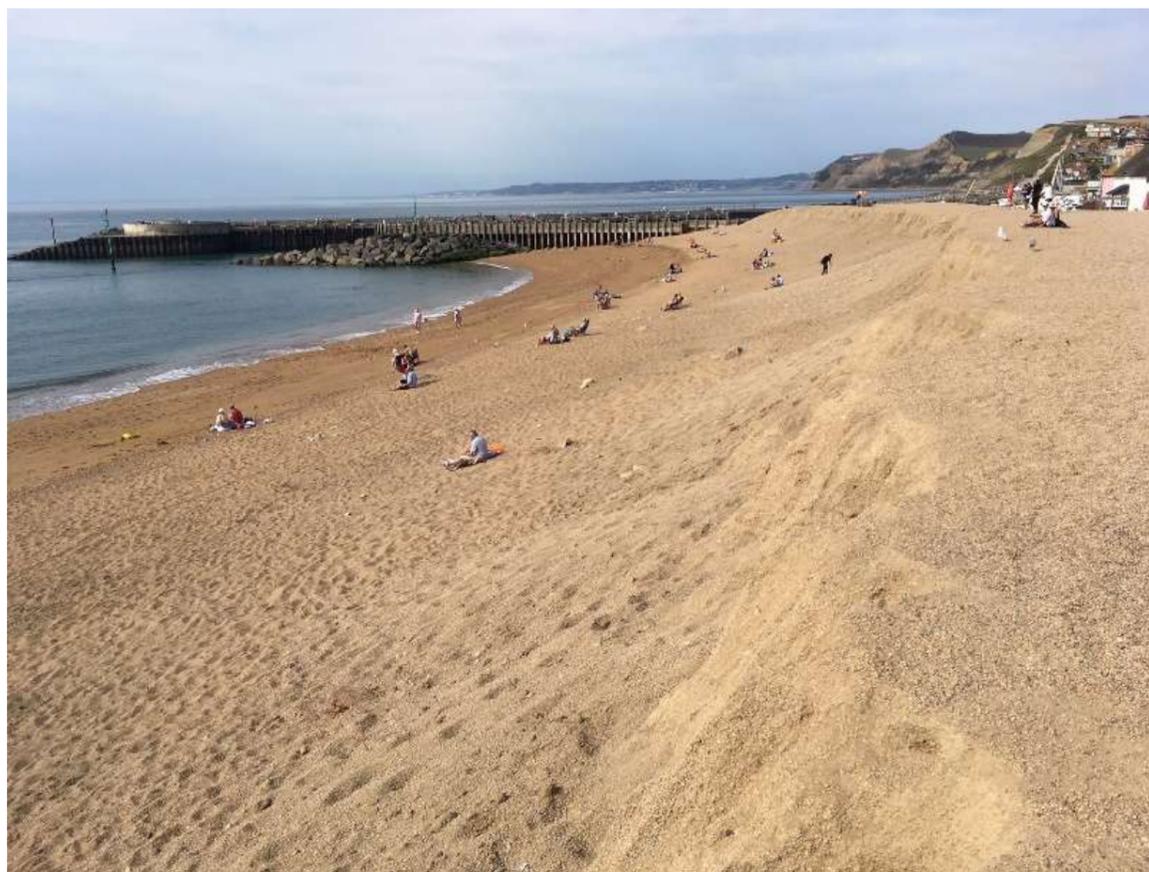
Beach levels at East Beach have been dropping slowly for most of 2020 and are now at some of the lowest levels recorded. This has reduced the width of the beach crest and created a steep front beach face in several places, partly exacerbated by the very low beach levels. Our flood defence work last year disturbed the shingle of the beach crest and caused fine material, like clay and sand, to form a hard crust in many areas. This means that the beach is now less mobile, more compacted and steeper in places than normal. Beach material that is well sorted and washed by the sea or heavy rain will not form such steep slopes, although it is also more easily eroded by the wind and waves.

East Beach Sept 2020

Mechanical works using diggers at East Beach to reduce the steep front face of the beach were completed in March and July 2020, with similar mechanical works planned for the end of September 2020. These works to the beach crest have limited flood defence benefit and are only for amenity access to the beach. The works in September will allow better access at several locations, either end of the beach, whilst retaining the steeper crest for the remainder of the frontage. This current management approach is supported by Dorset Council.

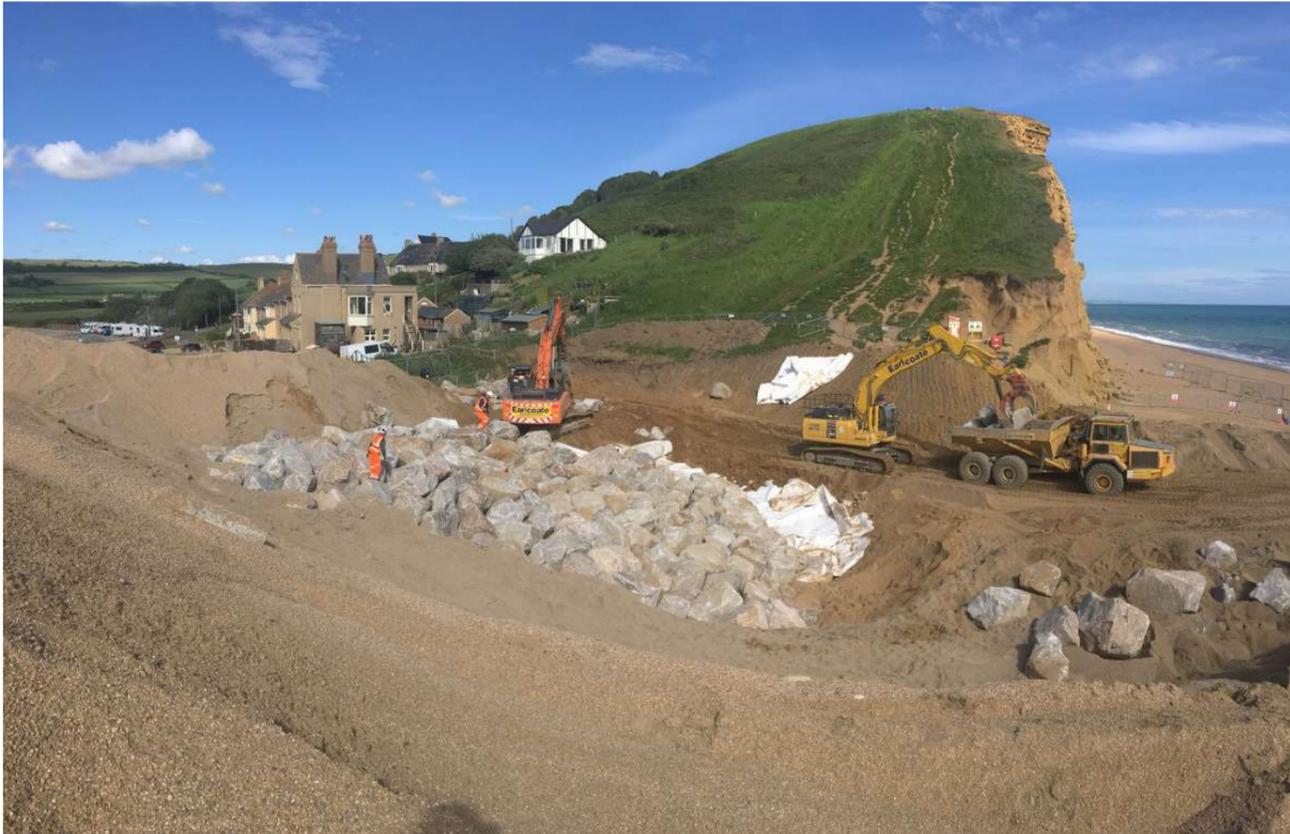
The beaches at West Bay form the primary flood defence as well as providing an amenity benefit, however both beaches have a secondary hard defence which acts to reduce the risk of flooding. At East Beach, once the beach material is eroded away, the rock revetment becomes exposed and acts to reduce wave overtopping during storm events. This is currently still buried beneath the beach and would only become exposed if further significant losses to the beach continued.

Rock revetment in construction at East Beach

Due to the local environmental designations at West Bay and the inclusion in the Jurassic World Heritage Site, the rock revetment at East Beach should remain buried in the beach as much as possible to preserve the natural appearance of this section of coastline.

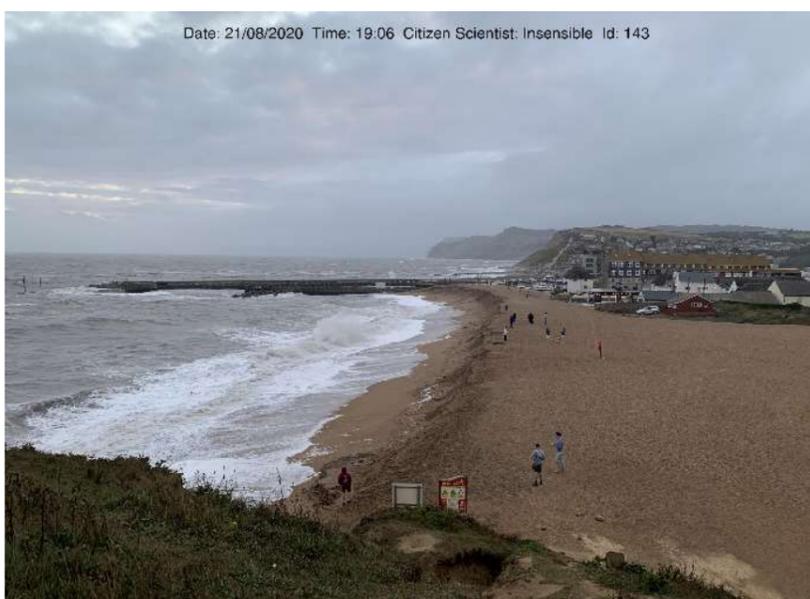
We regularly survey the beach using specialist equipment once a month to calculate beach levels and volumes. Our officers also visually inspect it during check rounds with photographic records kept. East Beach is also a site for the Coast Snap project, where members of the public can take a photo of the beach from the designated point on the coastal path and upload it to the Coast Snap website. This also forms an important record of beach monitoring and change for later analysis.

Example Coast Snap site image

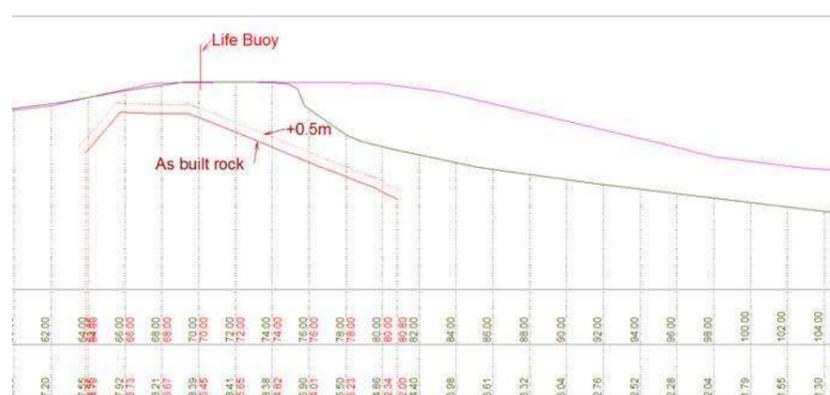
Example beach profile survey data

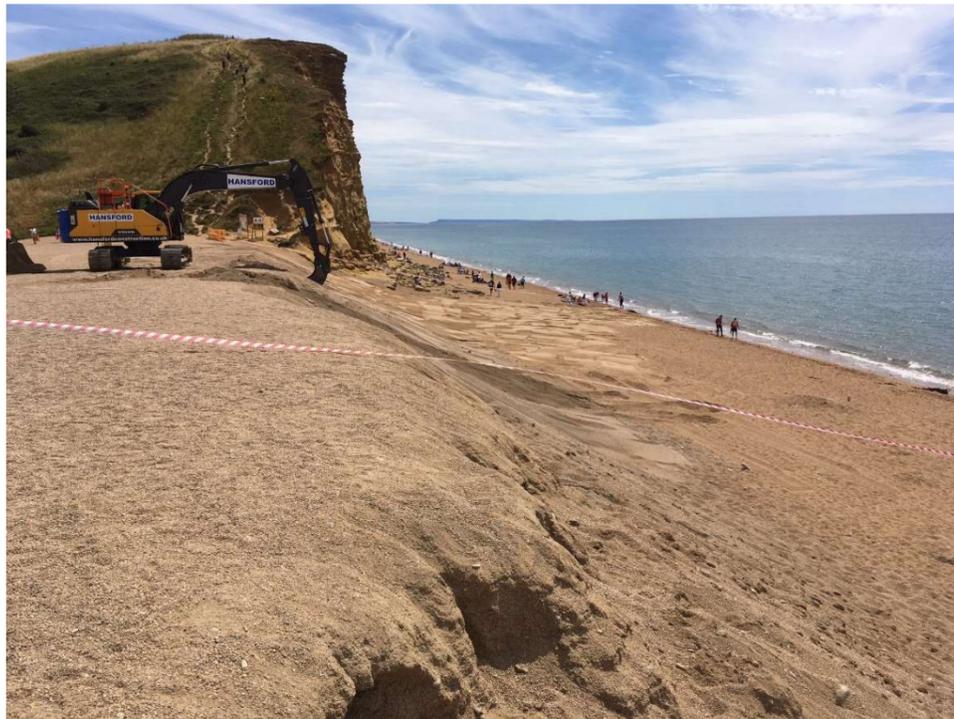
Beach works with a machine July 2020

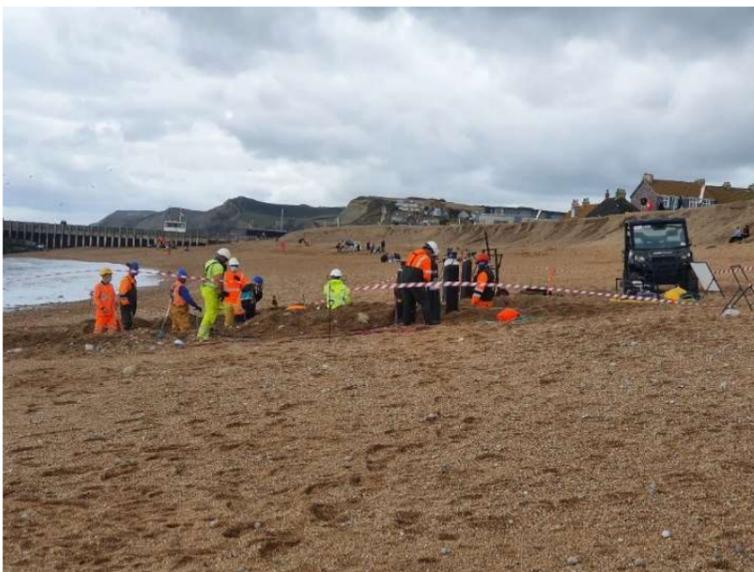
Beach works in August to remove steel sheet piling

An old Wessex Water pipe outfall in the beach may also be exposed when beach levels on the foreshore are low. This structure is surrounded by old steel sheet piling, which was partly removed by Wessex Water during August due to its exposure.

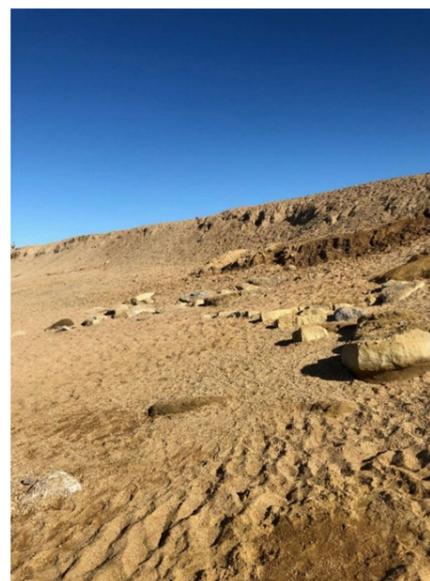
Exposed rock strata at the eastern end of East Beach

When the beach is very low, the natural rock at the eastern end of the beach can become exposed. This is not part of the recent new flood defence scheme and will naturally be covered again as beach material returns.
